Substandard Concrete Quality Analysis and Retrofit Feasibility in Post-Damage Two-Story Buildings

This study analyzes the structural condition of the Surakarta City DPRD Building after the damage using a combination of visual inspection, non-destructive testing (Hammer Test and PUNDIT), and numerical analysis based on ETABS and ABAQUS software. The results of the Hammer Test show that the quality of the concrete is in the range of 16–19 MPa and is below the minimum standard of K-250 according to SNI 2847:2019. PUNDIT testing confirms the inhomogeneity of concrete quality, where block elements have a better material density than columns and floor plates. ETABS analysis showed weaknesses in the lateral rigidity system, overstress in more than 68% of column elements, and non-conformance of column dimensions to the minimum standard. Further analysis using the Finite Element Method (FEM) showed that the existing columns work close to the limit of the material's capacity, while the jacketing simulation only provides a limited and potentially ineffective strength increase due to degradation of the old concrete and the risk of slip in the contact plane. Based on the integrative results of

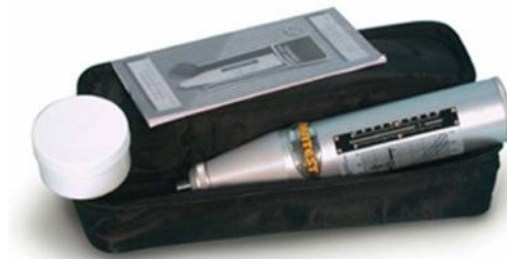
Figure 2. Hammer Test Matest type 380

Hammer test is applied to estimate the compressive strength of concrete based on the rebound value of the concrete surface. This method refers to SNI ASTM C805:2012. The stages of implementation include:

- The placement of the tool perpendicular to the concrete surface so that the impact occurs optimally.
- Controlled impact delivery using the hammer's internal energy.
- Recording of the reflected numbers read on the tool.
- Repeat the test for at least 10 points in each area to obtain a representative score.
- Evaluate the test surface to ensure no local damage due to cavities or inhomogeneity.

This method provides a preliminary picture of the uniformity and hardness of the concrete surface, which is correlated with the approximate value of f_c .

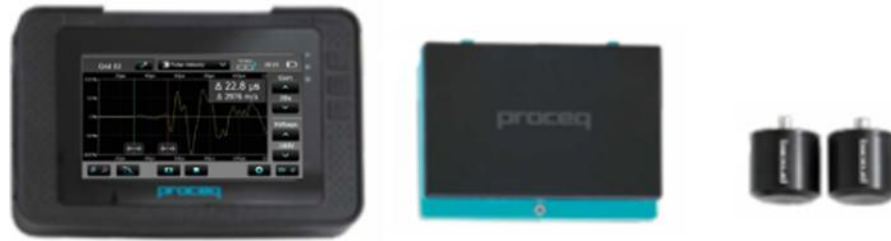
Figure 3. PUNDIT Test Kit

PUNDIT is used to assess concrete density, material homogeneity, and detect the presence of internal cracks through ultrasonic wave propagation speed measurement. The testing stages include:

- Calibration of the tool using standard media to ensure accuracy.
- Surface preparation through smoothing (if required) for optimal wave transmission.
- Couplant gel application to avoid air traps on sensor surfaces.
- The selection of test modes (direct, semi-direct, surface) is based on field conditions.
- Ultrasonic pulse velocity readings are then analyzed against possible internal damage.

Low propagation speed indicates high porosity, cracking, or deterioration in the quality of concrete. This data is then combined with the results of the hammer test for a more accurate assessment of the material.

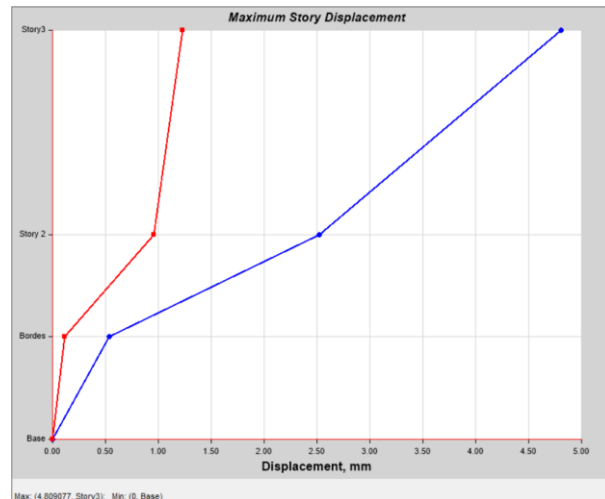
Figure 6. Max Displacement Direction X

The following is a check of the Maximum Deviation based on the ETABS Output at the Surakarta City DPRD Office

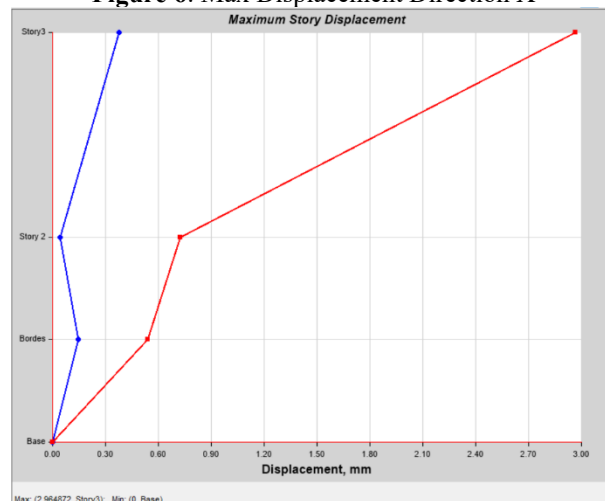
Figure 7. Max Direction Displacement Y

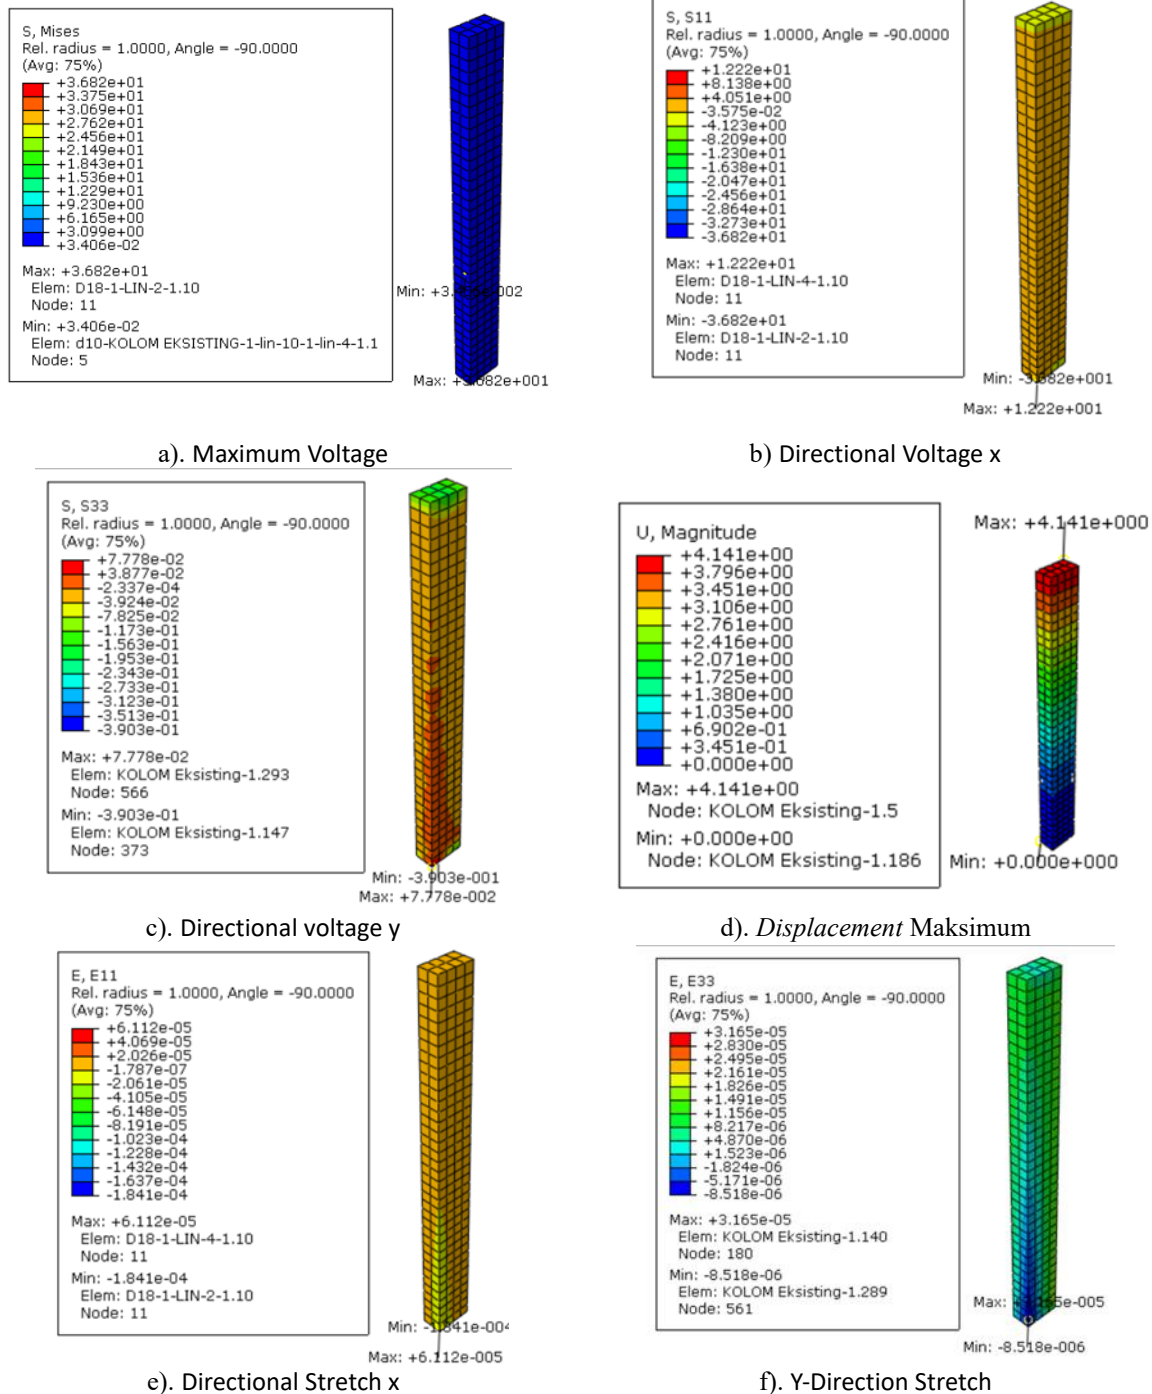
Figure 10. Analysis Results of Existing Columns

From the results of the analysis, it was obtained that the column received a von Mises voltage of 36.82 MPa, with an X directional voltage of 12.22 MPa and a Y directional voltage of 0.3903 MPa. The value of the X directional strain is 0.00001841, the Y-directional strain is 0.000003165, and the maximum displacement is

4,141 mm. These results show that the column is still working under elastic conditions and that the deformation that occurs is relatively small.

From the results of the Finite Element Method (FEM) analysis, the existing conditions show that the column receives a von Mises voltage of 36.82 MPa, with an X directional voltage of 12.22 MPa and a Y direction of 0.3903 MPa, and a maximum displacement of 4,141 mm. This indicates that although the columns are still in an elastic condition, the structure has shown indications of working close to the limit of material capacity.

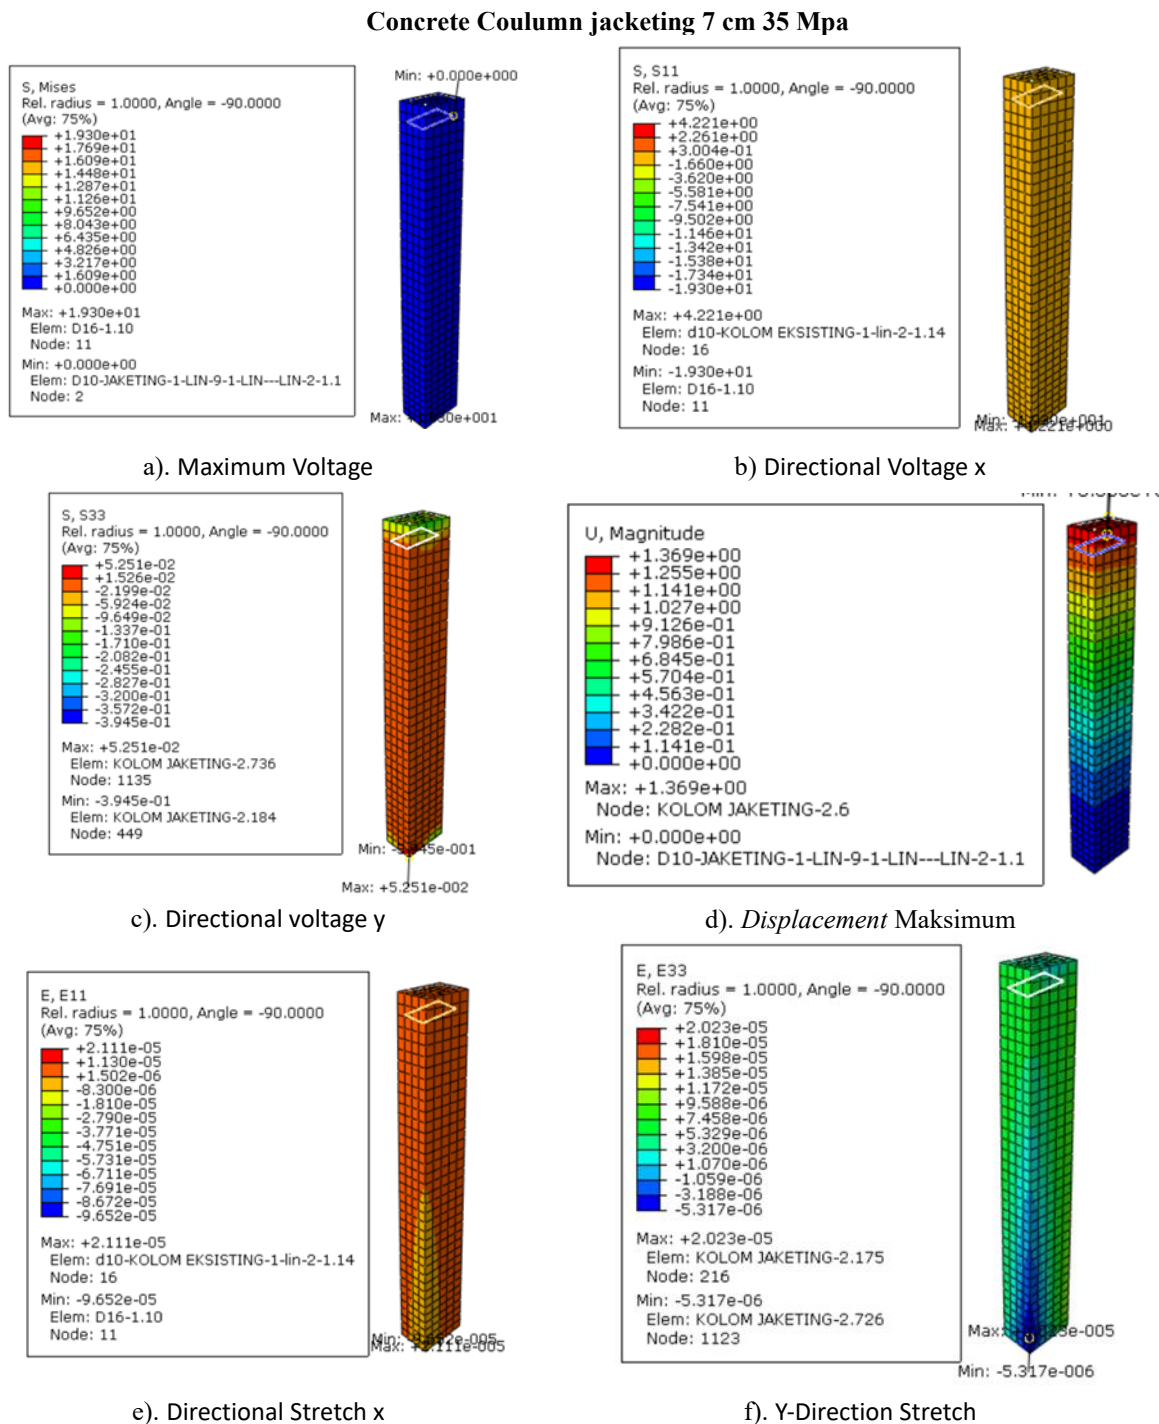
Figure 11. Jacketing Analysis Results 7 cm

From the results of the analysis, it was obtained that the column received a von Mises voltage of 19.3 MPa, with an X directional voltage of 19.3 MPa and a Y directional voltage of 0.3945 MPa. The value of the X directional strain is 0.000009652, the Y-directional strain is 0.000002023, and the maximum displacement is 1,369 mm. These results show that the column is still in a safe condition with relatively small deformation.

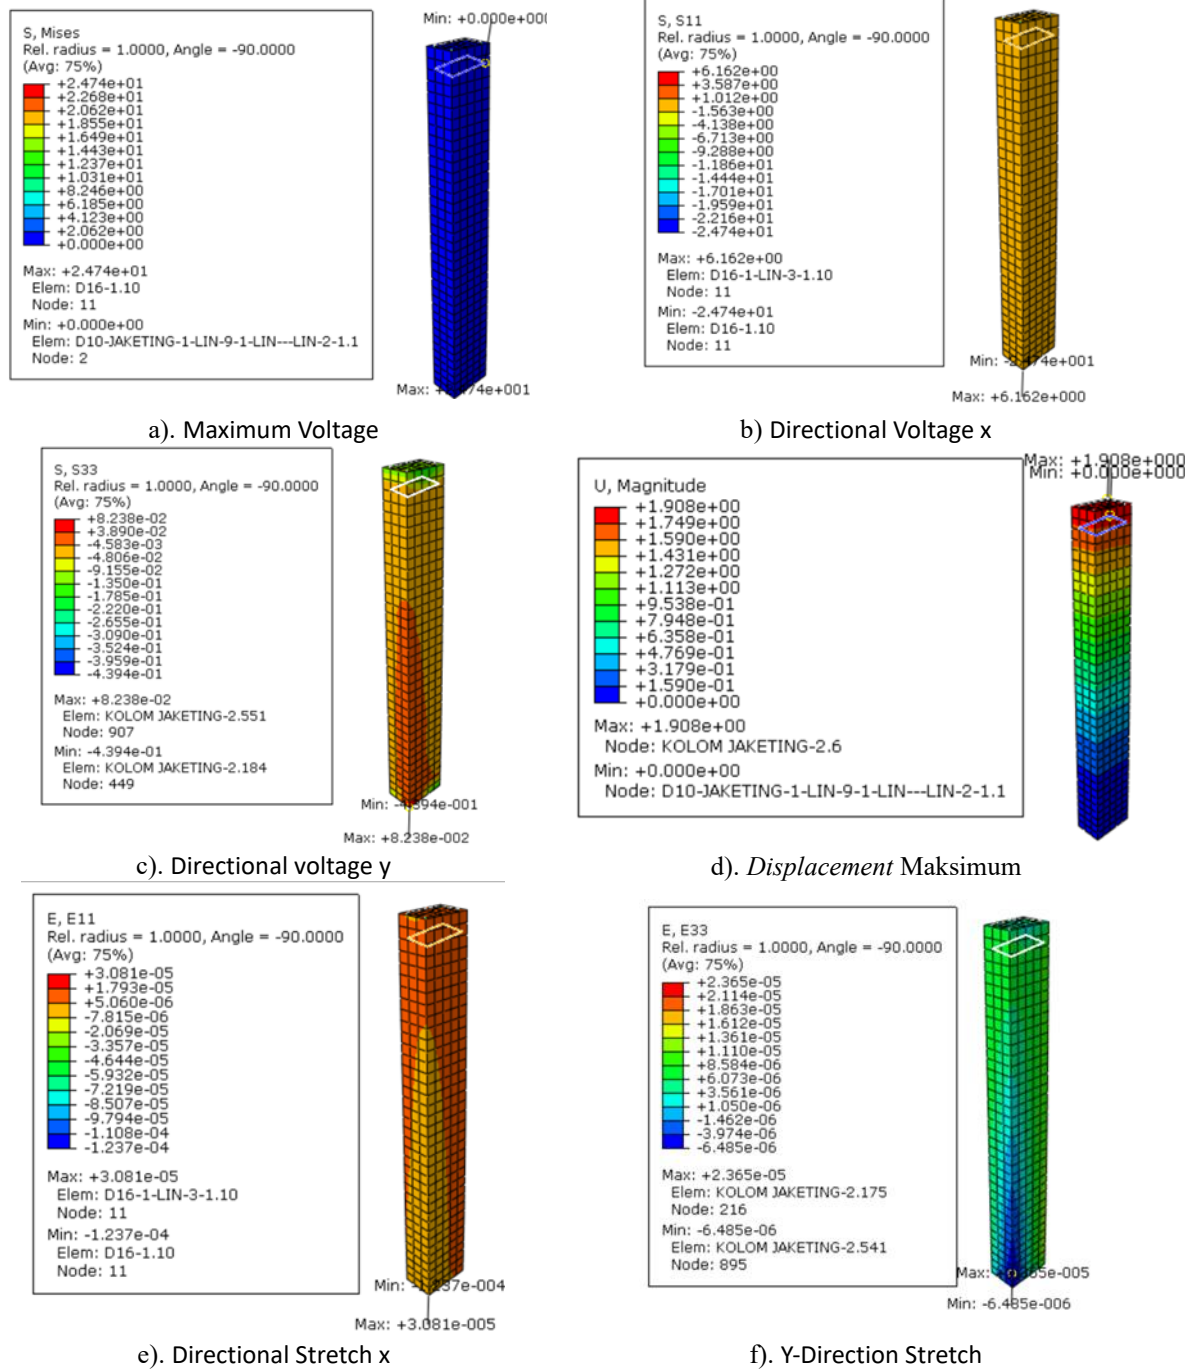
Figure 12. Analysis Results of Jacketing 5 cm

From the results of the analysis, it was obtained that the column received a von Mises voltage of 24.7 MPa, with an X directional voltage of 6.162 MPa and a Y directional voltage of 0.4394 MPa. The value of the X directional strain is 0.00011237, the Y directional strain is 0.00000265, and the maximum displacement is 1,908 mm. These results show that the column is still in a safe condition with relatively small deformation.
